Lazo Road – Town of Comox

Infrastructure Notes

COMOX VALLEY CYCLING COALITION

NOVEMBER 2020

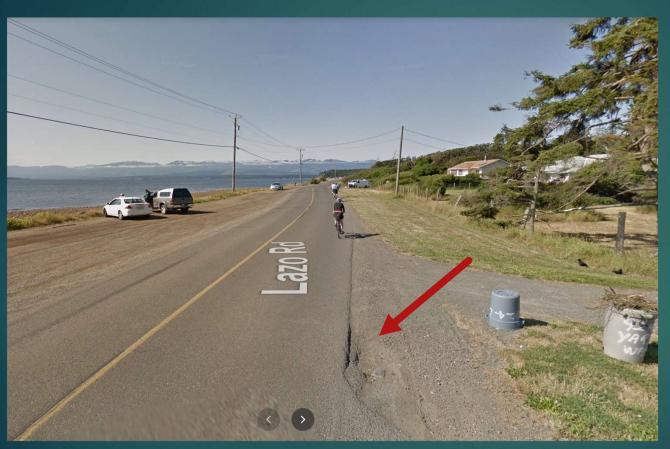
<u>Lack of Shoulder – Lazo Road</u>

- Streetview of westbound Lazo Rd near Southwind Rd (Pt Holmes)
- No paved shoulder for cyclists.
 Gravel on shoulder and parking lot is in poor condition and unsafe for cyclists
- High vehicle traffic area also with vehicles parking for Pt Holmes (backing out onto roadway)

- Add appropriate paved bike accessible shoulder to both sides of Lazo Road from Simba Road to Kye Bay R
- Coordinate work with MoTI so they can also add shoulders to Knight Rd from Kye Bay Rd to Airport
- Install no passing signage and line paint at portions of this route where vehicles often turn or near parking areas at Point Holmes

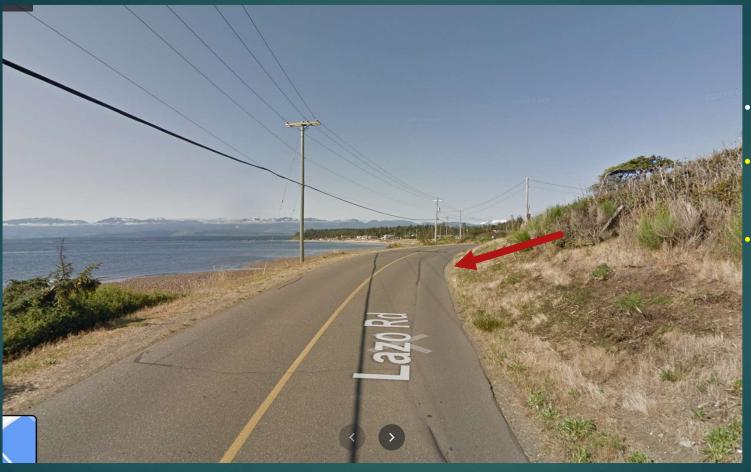
Dangerous Conditions on Lazo Road

- Views of westbound Lazo Rd
- Sharp edge on shoulder is a severe hazard to cyclists
- Blind corner with no room for error by vehicles or cyclists
