Anderton Road (Ryan Rd to Ellenor Rd)

Infrastructure Notes

COMOX VALLEY CYCLING COALITION

OCTOBER 2020

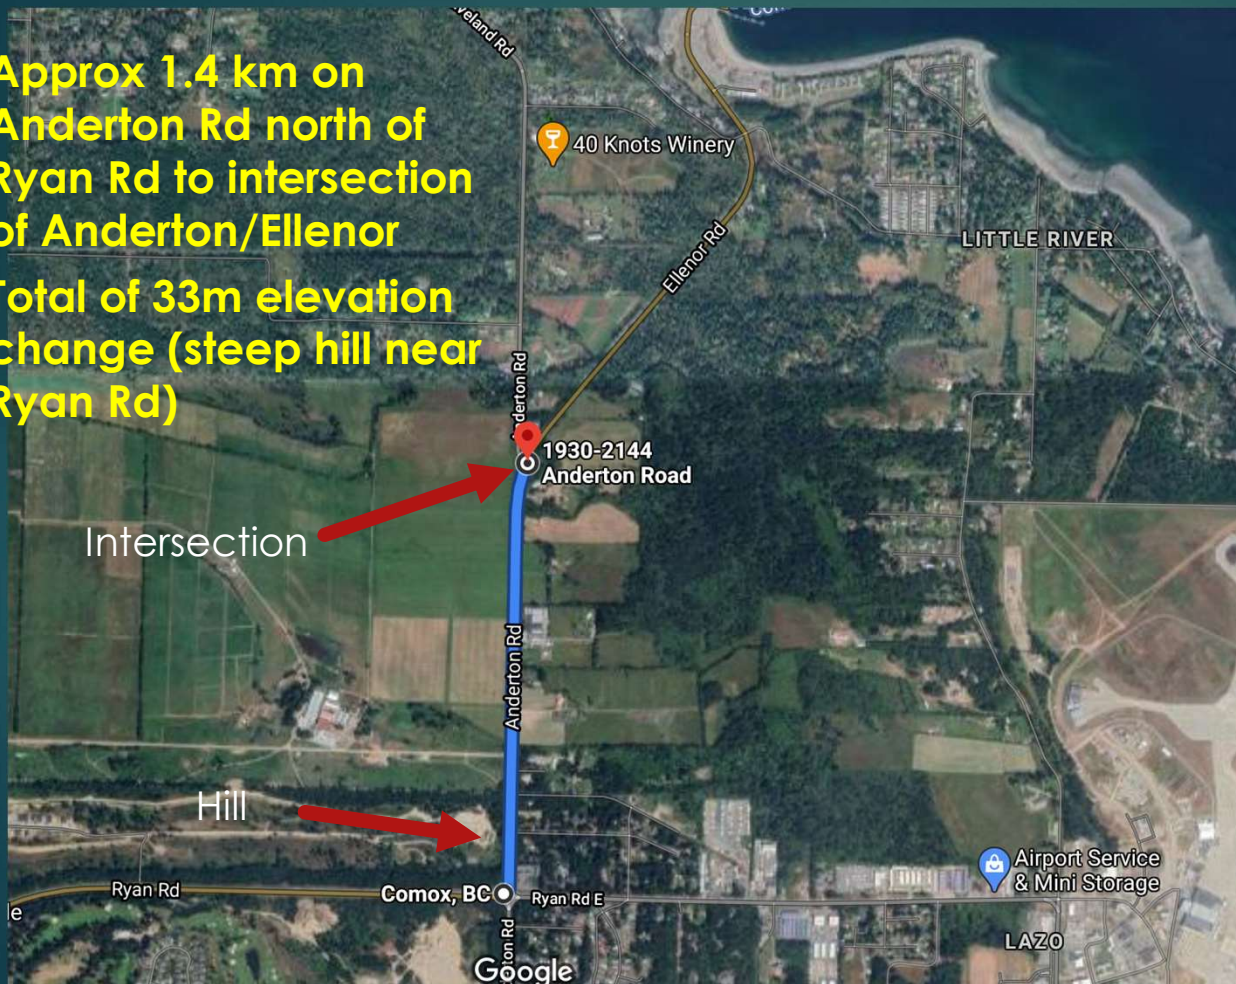
Anderton Road– Locator Map

- Approx 1.4 km on Anderton Rd north of Ryan Rd to intersection of Anderton/Ellenor
- Total of 33m elevation change (steep hill near Ryan Rd)

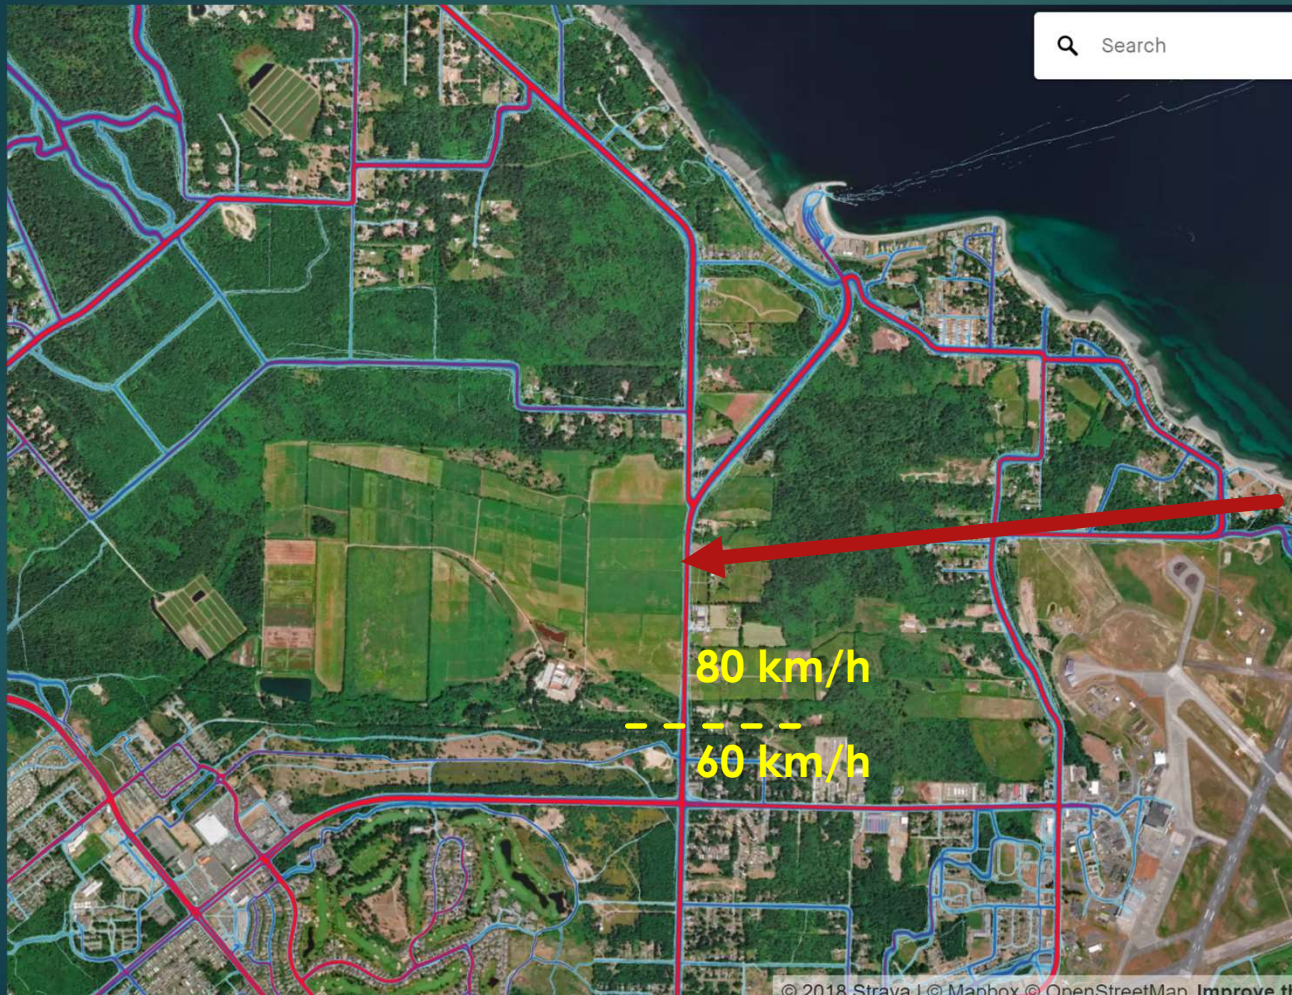
High Cyclist Use on This Route

- Strava Heatmap shows **use by cyclists is very high** (red color vs blue/purple for lesser used routes)
- Significant **commuter route** (to/from **Little River Ferry** terminal and other destinations).
- **High vehicle volume** and **speed limit** (80 km/h for majority, 60 km/h on hill from Hamilton Rd to Ryan Rd)

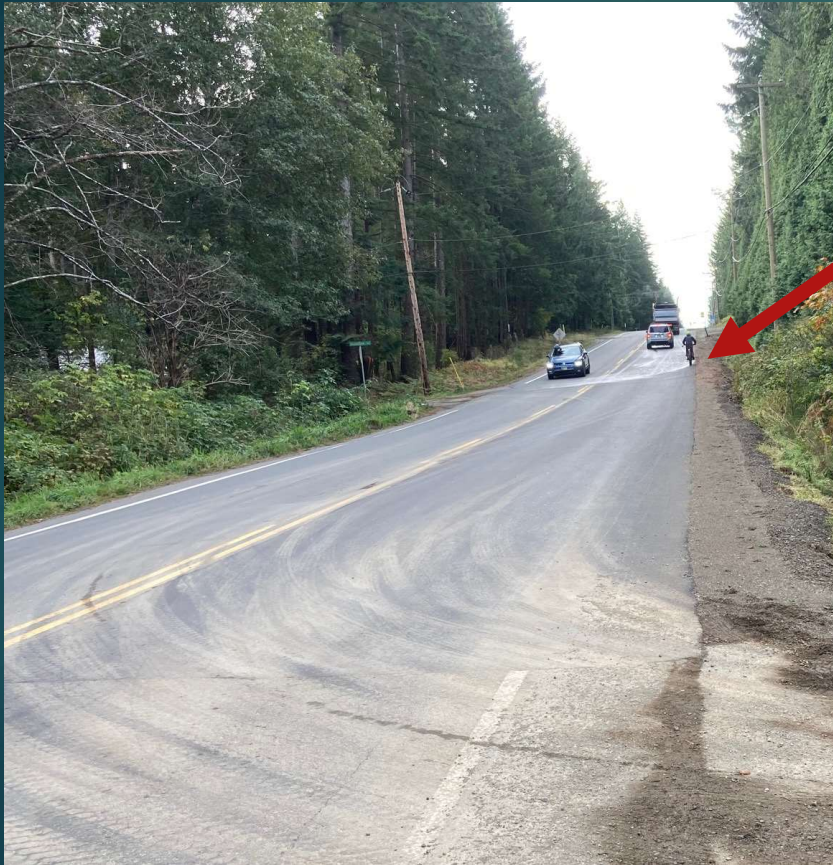
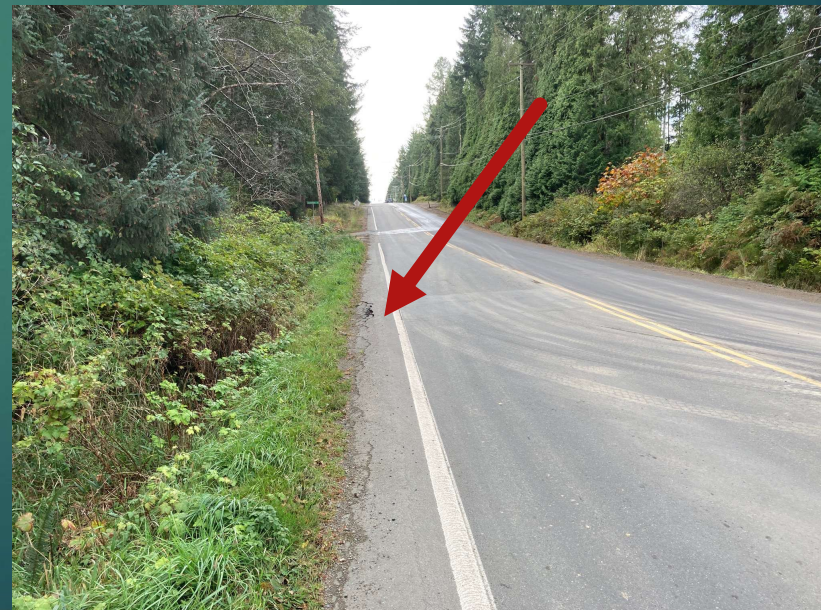
Extremely Poor Shoulder on Hill near Ryan Road

- Shoulders are narrow to begin with on this area and have degraded with use, as well as due to access road gravel movement
- Very dangerous situation for cyclists in a high speed/high volume traffic area

- **Immediate:** When repaving is being conducted for Greenwood **sewer line** extension - include **widening and paving of shoulders on Anderton Road hill** (Ryan Rd to Hamilton Rd)
- **Immediate:** **Reduce speed limit** on Anderton Rd **from 80 km/h to 60 km/h** (Hamilton Rd to Ellenor Rd) until shoulders can be widened and repaved
- **Add appropriate paved bike accessible shoulder** to both sides of Anderton Rd (Ryan Rd to Ellenor Rd). Width should be commensurate to rural BC guidelines.
- **Repair and widen shoulders** at **intersection** of Anderton Rd and Ellenor Rd

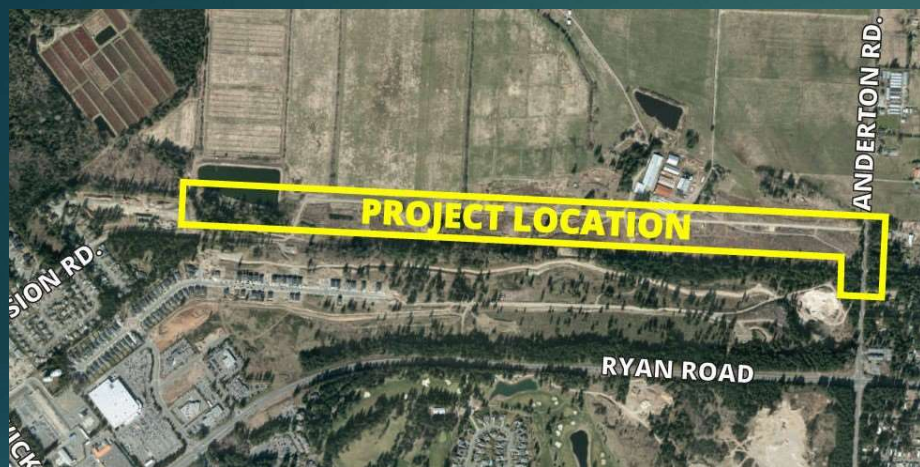
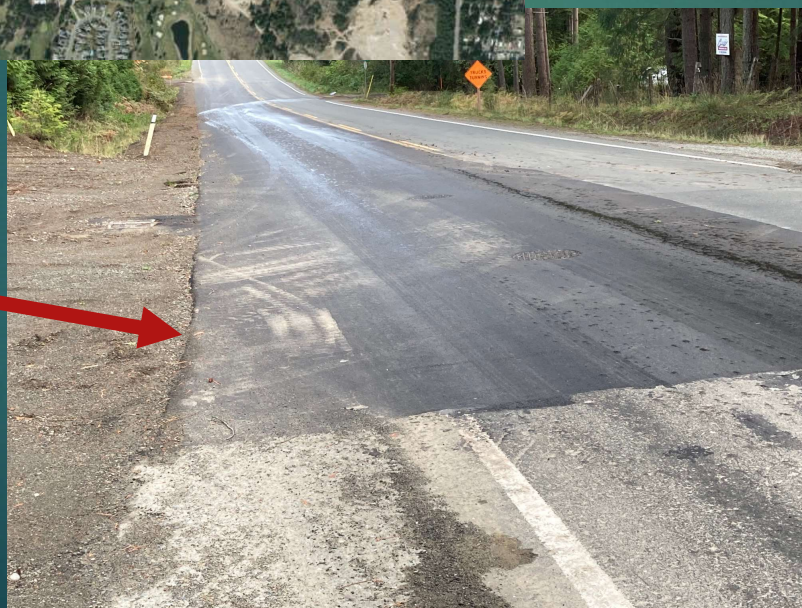
Sewer Line Work – Timing for Re-Paving

Excavation

- Greenwood sewer line was extended in Sept 2020 by City of Courtenay and a portion of Anderton Road was excavated in the process
- When the road was repaved, it would have been an opportune time to also widen and repave the shoulders on the hill portion of Anderton. This is a perfect example of where CVCCo hopes to see better co-operation between road jurisdictions.

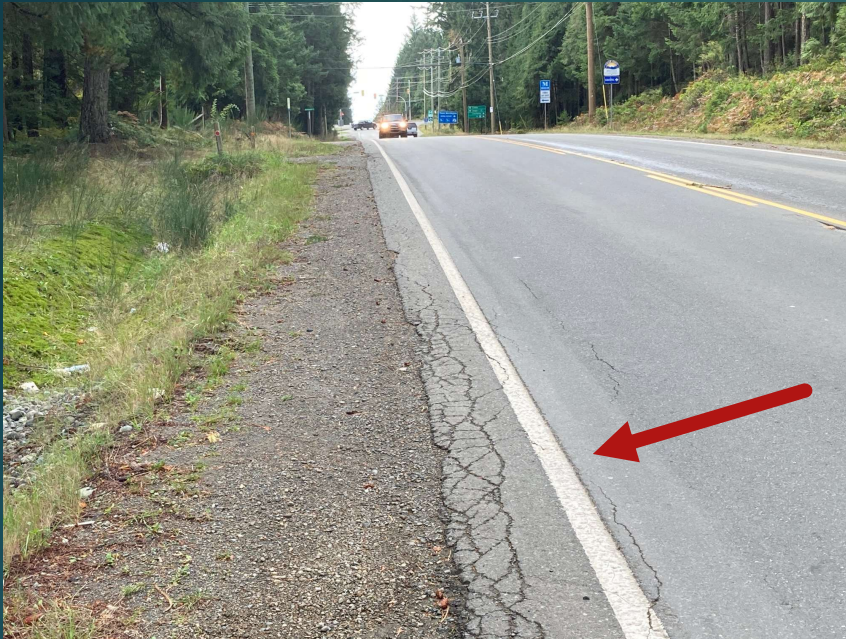
Narrow Shoulders – Anderton Road

- Both shoulders are very narrow from Hamilton Rd north to Ellenor Rd intersection
- At 80 km/h, current shoulder width is definitely not safe to allow vehicles to pass cyclists

Shoulder is very narrow and degraded to point of being dangerous

Speed Limit = 60-80 km/h

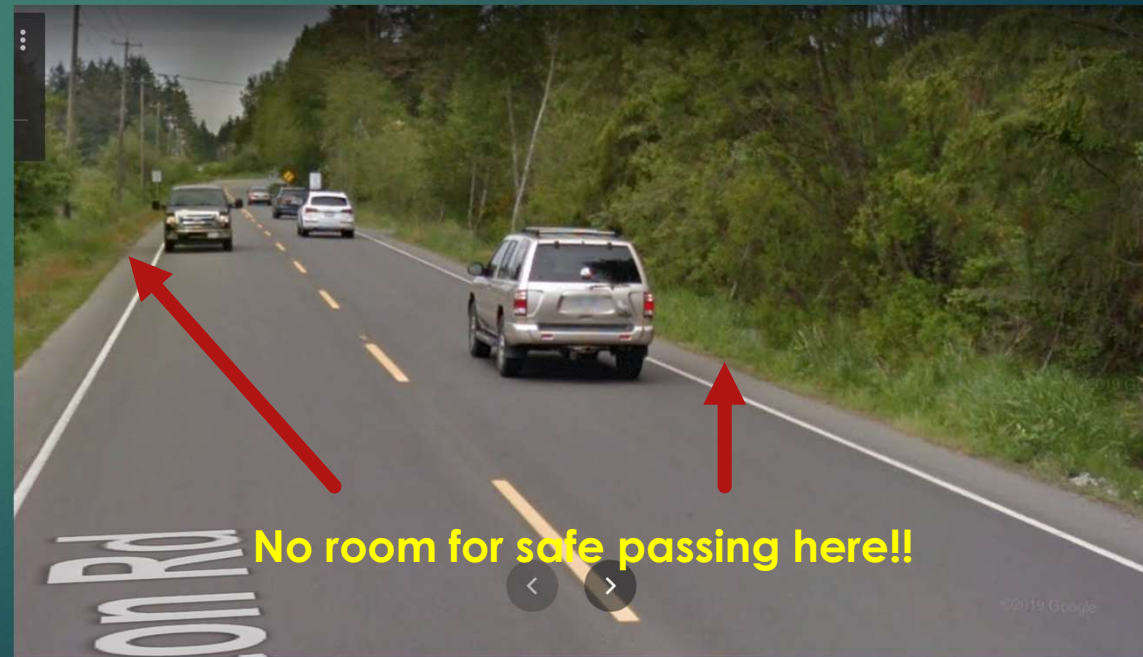
BC Rural Road Design Guide

- **80 km/h** on this highly used route requires a Bicycle Accessible shoulder by the BC design guide
- Unsure which design standard applies but **minimum shoulder should be 1.5m**

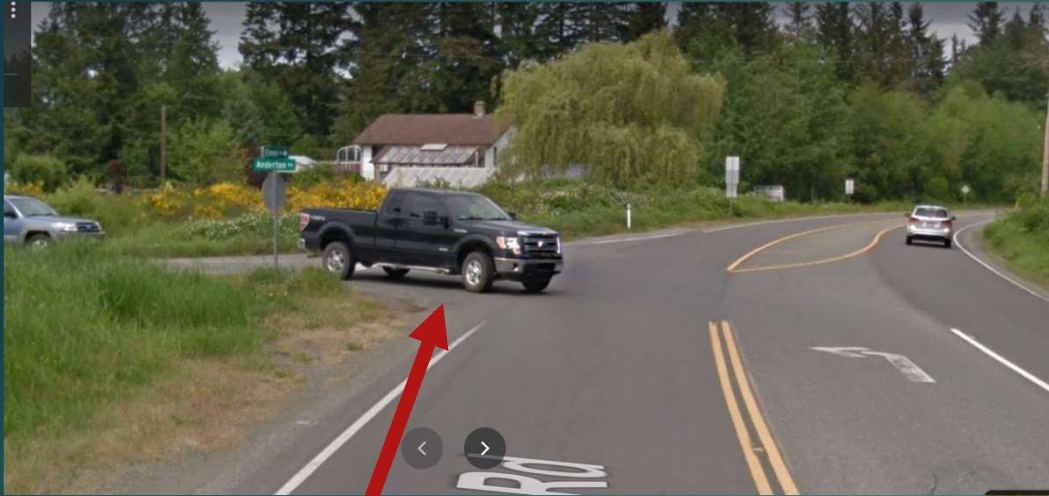
Intersection – Anderton/Ellenor Roads

Shoulder has degraded and edges around this corner also need to be widened for safety

Speed Limits = 70-80 km/h

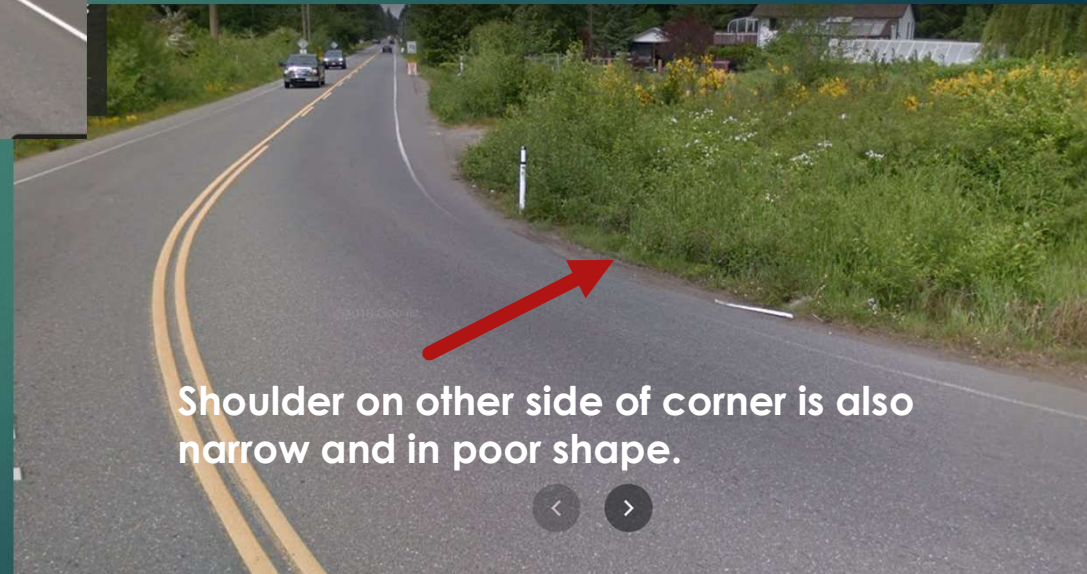
Shoulder on other side of corner is also narrow and in poor shape.
