Seal Bay (Bates and Coleman Road) Infrastructure Notes

COMOX VALLEY CYCLING COALITION
OCTOBER 2020

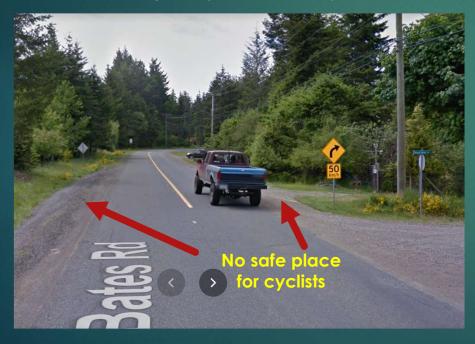
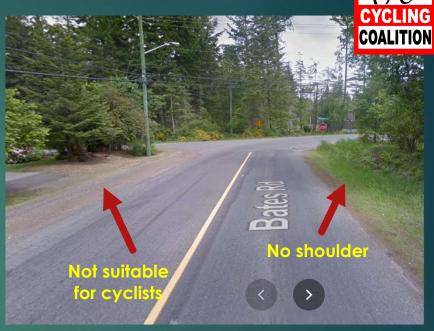
Bates Rd near Waveland Rd

<u>Poor Shoulder – Bates Road</u>

- Shoulders on Bates Rd are either nonexistent or unpaved and dangerous for cyclists
- Speed limit is 70 km/h
- Poor visibility, very shaded in spots

- Immediately reduce speed limits from 70 and 80 km/h to 50 km/h on Bates Road and the portion of Coleman Rd where shoulders are not adequate.
- Install no passing signage/line paint and marked crosswalks with signs at the Seal Bay Bates Road parking lot.
 Traffic must be calmed through this parking area or there is high risk of a serious accident.
- Widen (as necessary) and pave shoulders on Bates
 Road
- Add appropriate paved bike accessible shoulder to both sides of Coleman Rd from Bates Rd to Left Rd
- Widen eastbound shoulder of Coleman Rd from Hwy 19A to Left Rd

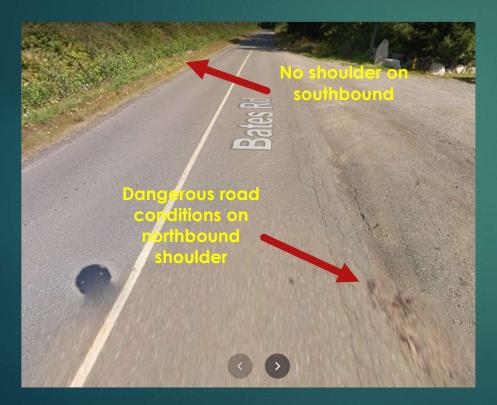
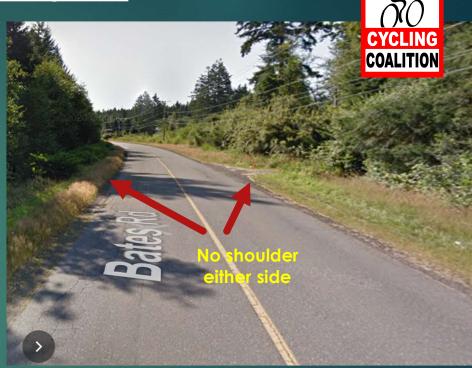
Bates Rd near Anson Rd

<u>Bates Road – North of Seal Bay Park</u>

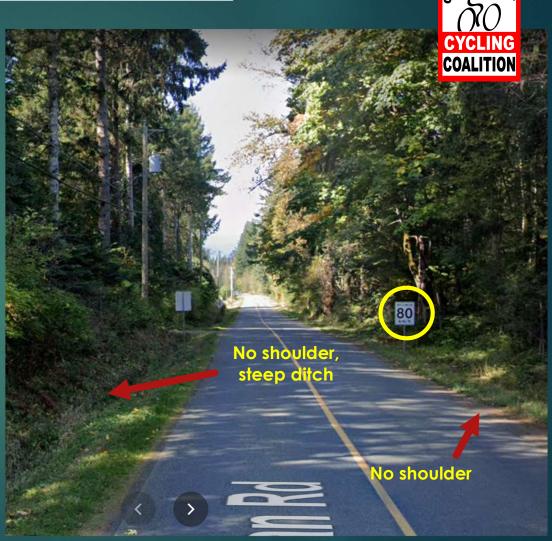
<u>Coleman Road – Bates to Left Road</u>

- No Shoulders on Coleman Rd from Bates Rd to Left Rd intersection
- Speed limit is 80 km/h
- Poor visibility due to shading and corners

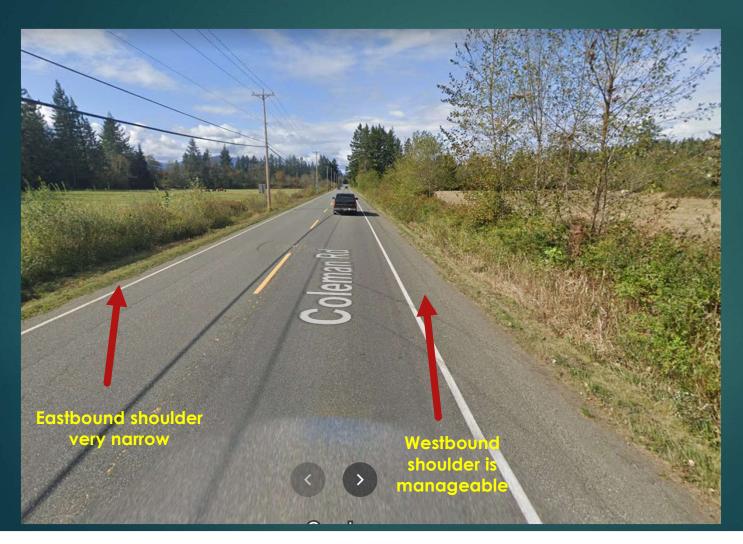
<u>Coleman Road – Between Left Rd and 19A</u>

- Westbound shoulder is ok, but eastbound needs to be widened
- Speed limit is 80 km/h

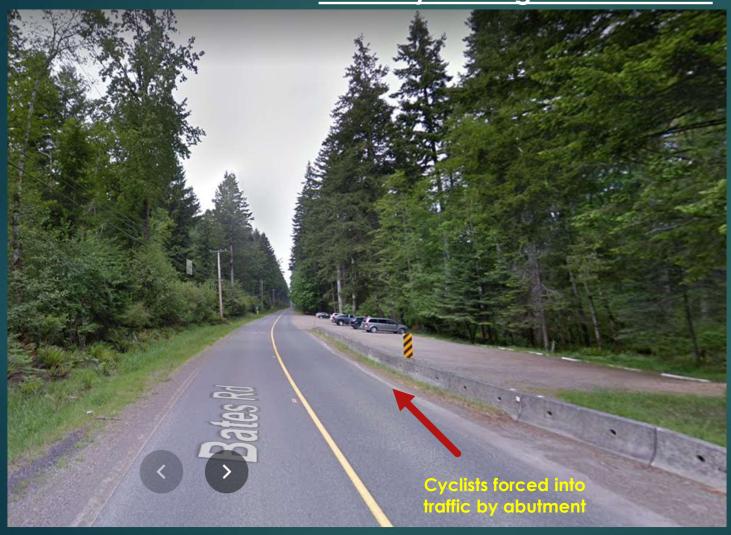
<u>Seal Bay Parking Lot – Bates Rd</u>

- Bates Rd passes through Seal Bay Nature Park (SBNP)and there is a wellused parking lot adjacent to the roadway
- SBNP is popular with nature lovers, hikers, dog walkers, runners and cyclists
- Dangerous situation at parking area with high speed traffic (70 km/h) and no shoulders

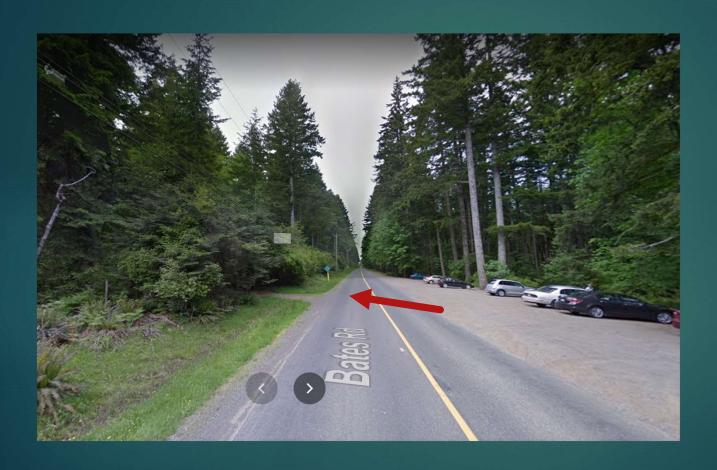
Seal Bay Parking Lot – Crossing of Bates Rd

- There are two trails at the parking lot which require pedestrians to walk across Bates Road to access
- Again, a very Dangerous situation at parking area with high speed traffic (70 km/h) and no crosswalk, signs or traffic calming
